Contract #: 04-0120F4Cty: SF/ALA Rte: 80 PM: 13.2/13.9File #: 69.28**WELDING INSPECTION REPORT****Resident Engineer:** Pursell, Gary**Address:** 333 Burma Road**City:** Oakland, CA 94607**Report No:** WIR-002367**Date Inspected:** 12-May-2008**Project Name:** SAS Superstructure**OSM Arrival Time:** 630**Prime Contractor:** American Bridge/Fluor Enterprises, a JV**OSM Departure Time:** 1530**Contractor:** Zhenhua Port Machinery Company, Ltd (ZPMC), Changxing Island **Location:** Shanghai, China**CWI Name:** Li Yan Hua**CWI Present:** Yes No**Inspected CWI report:** Yes No N/A**Rod Oven in Use:** Yes No N/A**Electrode to specification:** Yes No N/A**Weld Procedures Followed:** Yes No N/A**Qualified Welders:** Yes No N/A**Verified Joint Fit-up:** Yes No N/A**Approved Drawings:** Yes No N/A**Approved WPS:** Yes No N/A**Delayed / Cancelled:** Yes No N/A**Bridge No:** 34-0006**Component:** OBG**Summary of Items Observed:**

WELDING INSPECTION REPORT

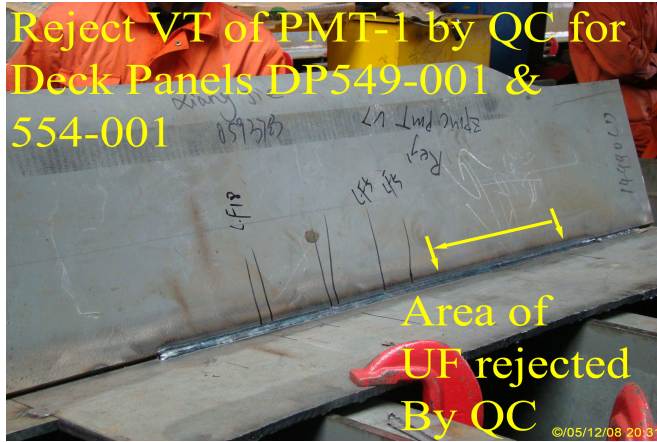
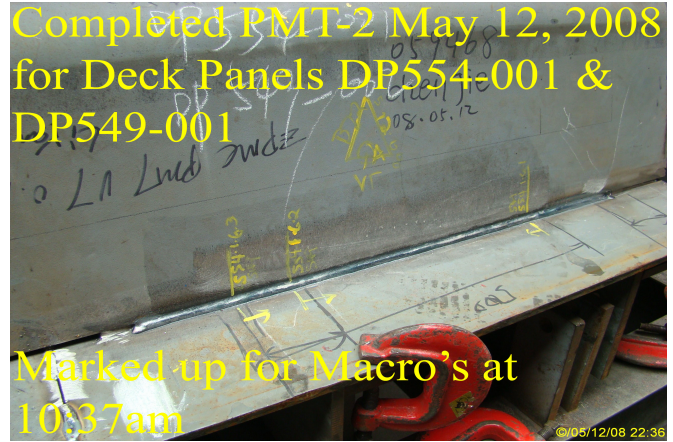
The Caltrans QAI observed welding utilizing the dual process WPS-B-T-2342-U1 (U-rib)-3 welding procedure specification for closed rib welding of the Production Monitoring Test (PMT) #1 for Production Panel DP549-002 and DP554-001 on closed U-rib Partial Joint Penetration (PJP) welds in Bay #1. ZPMC welding personnel performed Gantry Machine, Gas Metal Arc Welding (GMAW) for the root pass and immediately performed Gantry Machine, Submerged Arc Welding (SAW) for the cover/final pass on PMT #1, using gantry machine #1. Upon completion of the SAW pass on U-rib PJP welds on PMT #1 Visual Testing (VT) was performed on weld #1 through #6 by ZPMC personnel and was unacceptable. The process was completed again for PMT #2. PMT #2 Visual Testing (VT) was performed on weld #1 through #6 by ZPMC personnel and was acceptable, and then VT was verified by the Caltrans QAI. Ultrasonic Testing (UT) was then performed by ZPMC inspector and PMT #2 was determined to be acceptable. Macro etch samples were selected by the Caltrans QAI on PMT #2.
